ANNUAL REPORT FOR 2003

Lengyel Mitigation Site
Craven County
Project No. 8.1170806
TIP No. B-2531WM

Office of Natural Environment & Roadside Environmental Unit
North Carolina Department of Transportation
December 2003

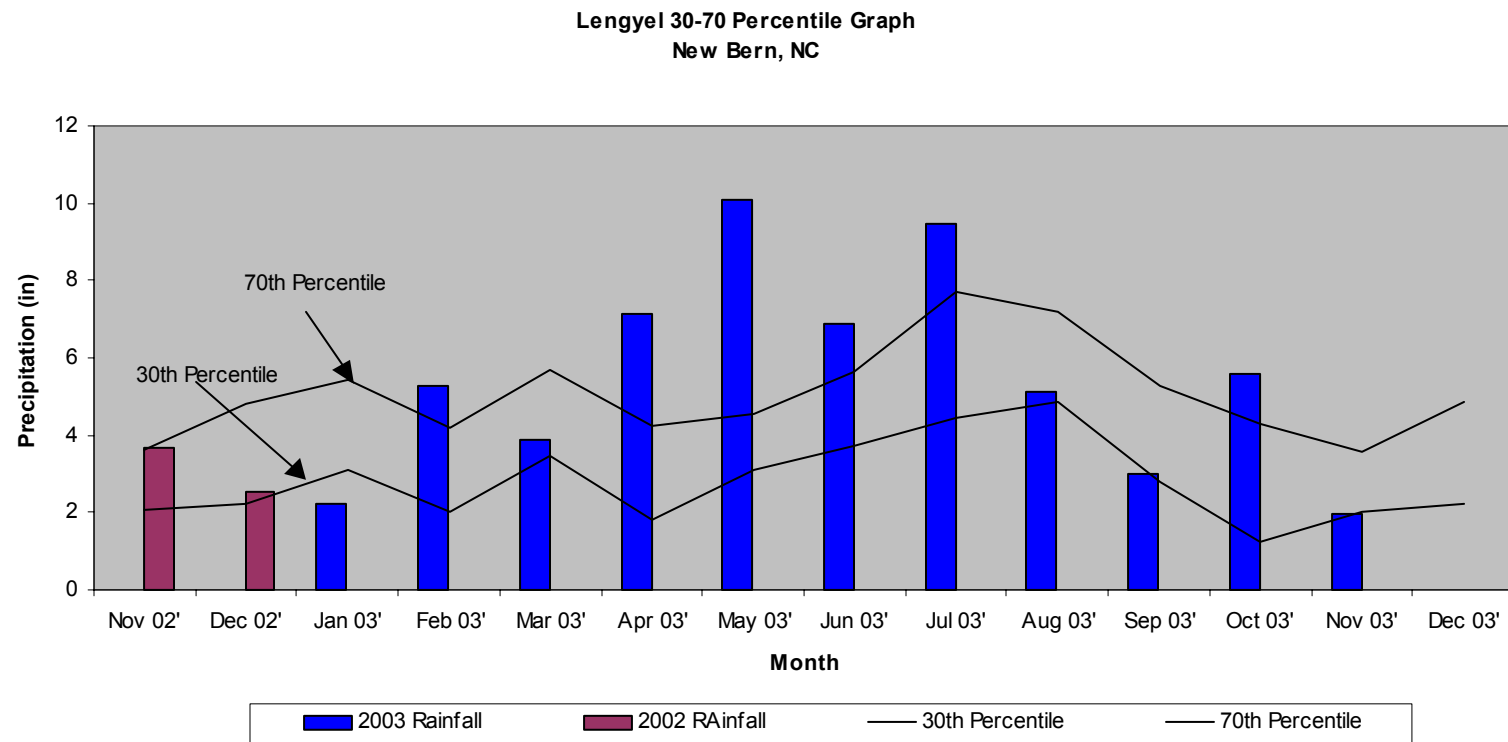
Figure 4. Lengyel Site 30-70 Percentile Graph, New Bern, NC

Figure 4 is a comparison of the 2003 monthly rainfall to the historical precipitation (collected between 1972 and 2003) for New Bern, North Carolina. This comparison gives an indication of how 2003 relates to historical data in terms of climate conditions. The NC State Climate Office provided all local rainfall information.

For the 2003-year, February, April, May, June, July, and October experienced above average rainfall. The months of January, September, and November recorded below average rainfall for the site. November (02'), December (02'), March, and August experienced average rainfall. Overall, 2003 experienced an average rainfall year.
